Special Council Assessment Panel Agenda & Reports

15 August 2023

TREE TO BE REMOVED 1 Kensington Road & 39 Clarke Street, Norwood

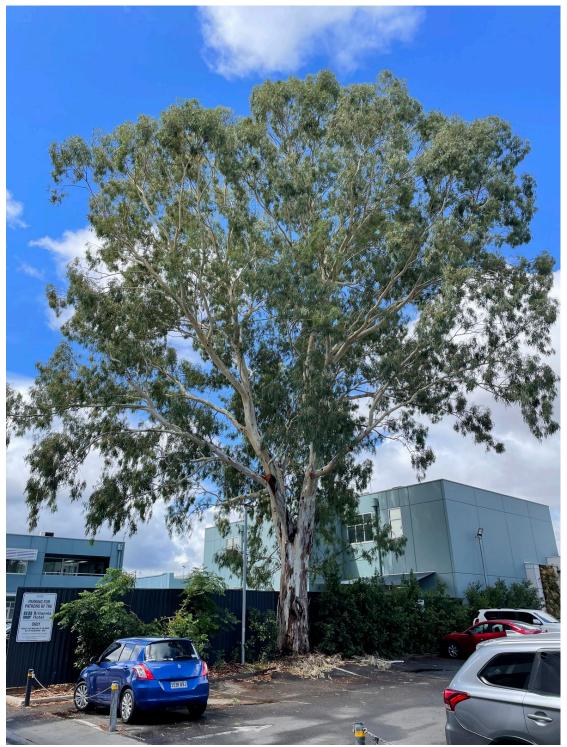
Figure 1. My photograph of the subject tree, looking approximately south-east from Wadham Lane on the 8th of March 2023, following the recent pruning of the tree (in February 2023) and the recent branch failure events from the tree (in January and February 2023). Note the large canopy of the tree overhanging a number of formal car parking spaces within the car park of the Britannia Hotel.

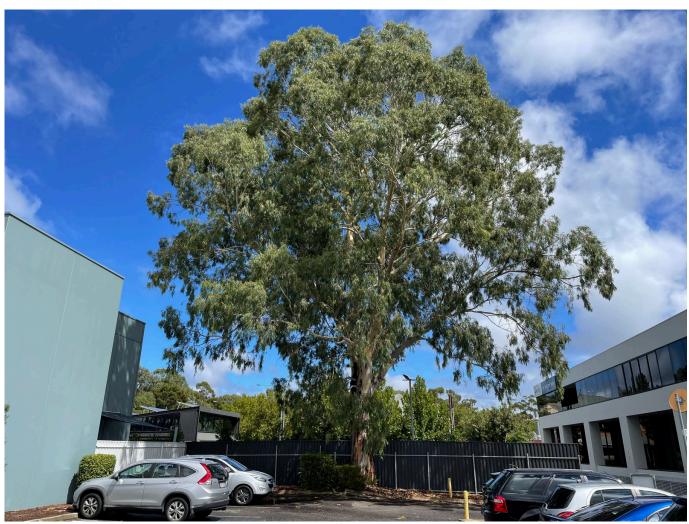
Figure 2. My photograph of the subject tree, looking approximately west from the carpark at 37-39 Wadham Lane on the 8^{th} of March 2023, following the recent pruning of the tree (in February 2023) and the recent branch failure events from the tree (in January and February 2023). Note the large canopy of the tree overhanging a number of formal car parking spaces within the car park at 37-39 Wadham Lane.

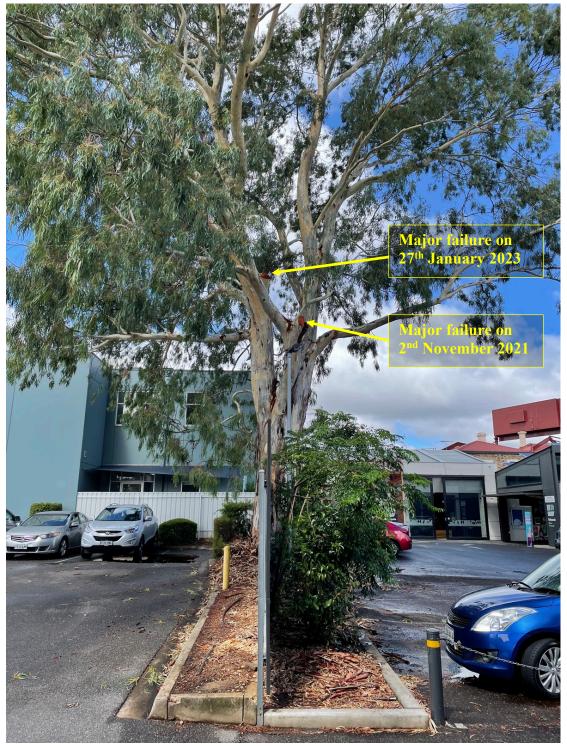
Figure 3. My photograph of the subject tree, looking south from Wadham Lane on the 8^{th} of March 2023. The pruning scars of the stubs from the two largest structural failures in the tree are indicated. Note that the canopy of the tree overhanging numerous car parking spaces at the Britannia Hotel carpark and in the neighboring allotment of 37-39 Wadham Lane.

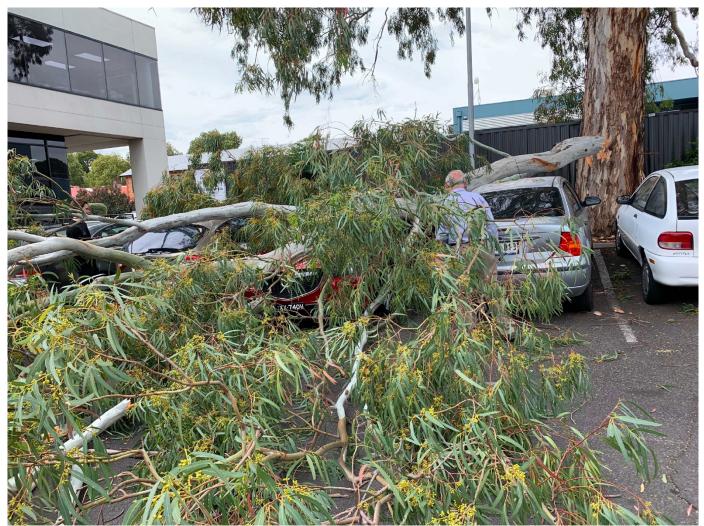
Figure 4. Photograph of the subject tree and the branch failure that occurred on the 2^{nd} November 2021 (photo taken by others and provided to me by Phillip Brunning of Phillip Brunning and Associates), looking approximately east from the Britannia Hotel carpark. Three vehicles were damaged by this branch failure event, which occurred in non-extreme weather.

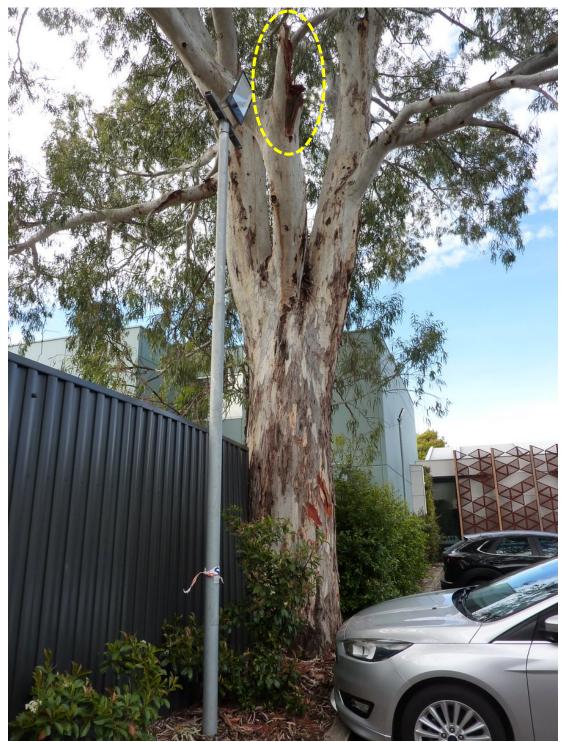
Figure 5. My photograph of the subject tree, looking approximately south from the Britannia Hotel carpark on the 9th of November 2021 (following a recent major branch failure). The superimposed yellow ring indicates the recent branch failure scar. This failure occurred in a healthy branch, at an internodal point, and in non-extreme weather, and is therefore indicative of a sudden branch failure event. The failed branch was likely over-extended and end-weighted (like most branches forming the canopy of the tree) and the failure scar indicates large longhorn borer galleries in the heartwood – both of these likely contributed to the failure of this branch (also see Figure 6). This failure scar has now been pruned back more cleanly, presumably for aesthetic reasons (see Figure 7).

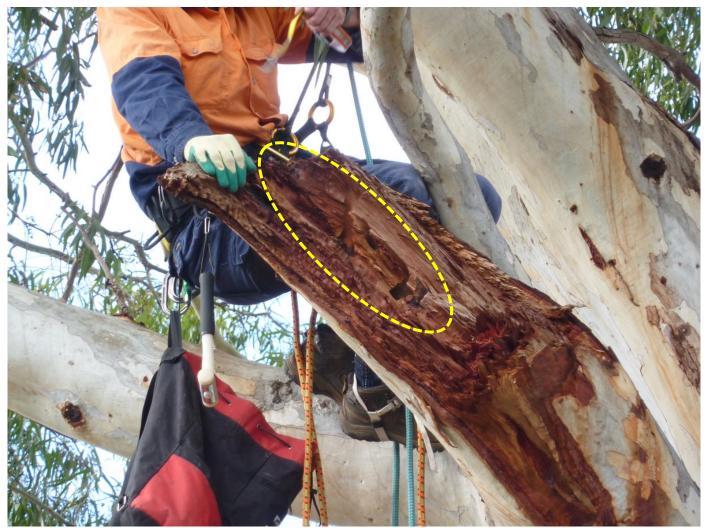
Figure 6. My photograph of the scar caused by the recent failure of a major branch from the tree, photographed on the 7th of June 2022. This failure occurred in a healthy branch, at an internodal point, and in non-extreme weather, and is therefore indicative of a sudden branch failure event. The failed branch was likely overextended and end-weighted (like most branches forming the canopy of the tree) and the failure scar indicates large longhorn borer galleries in the heartwood – both of these likely contributed to the failure of this branch. The superimposed yellow ring indicates the area where longhorn borers have created large heartwood galleries and pupal chambers. This failure scar has now been pruned back more cleanly, presumably for aesthetic reasons (see Figure 7).

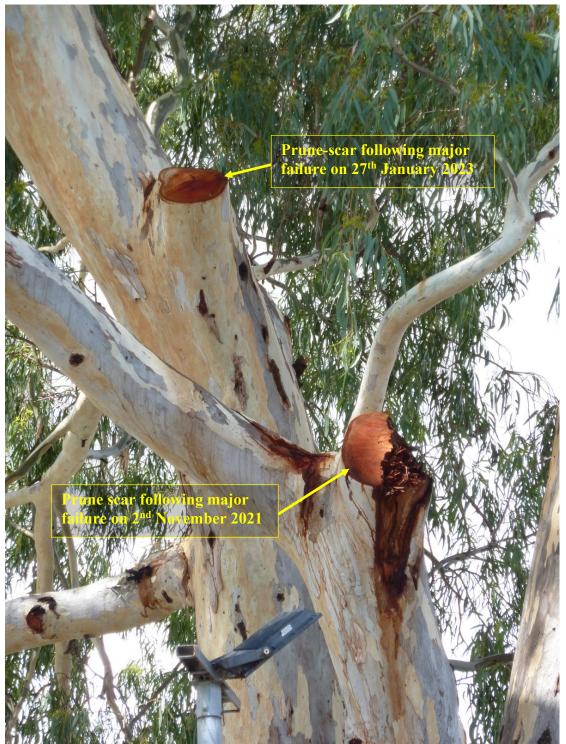
Figure 7. My photograph of the subject tree, looking approximately south-east from the Britannia Hotel carpark on the 8^{th} of March 2023. The pruning scars of the stubs from the two largest structural failures in the tree are indicated. Both of these failure scars have been pruned back more cleanly, presumably for aesthetic reasons.

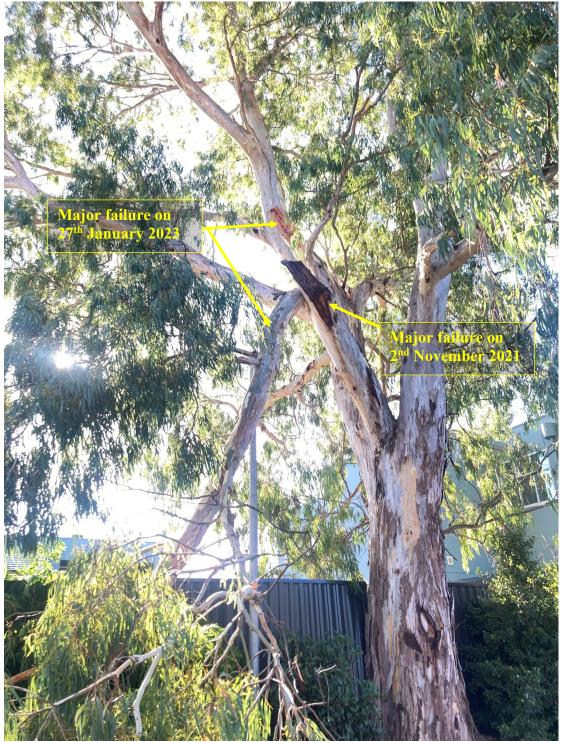
Figure 8. Photograph of the subject tree and the branch failure that occurred on the 27^{th} January 2023 (photo taken by others and provided to me by the client on the 27^{th} January 2023), looking approximately east from the Britannia Hotel carpark. Also note the failure scar from the 2021 major branch failure.

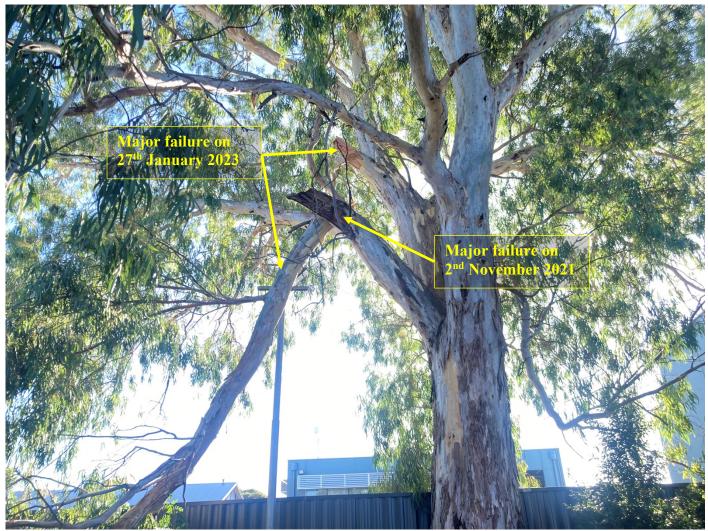
Figure 9. Photograph of the subject tree and the branch failure that occurred on the 27th January 2023 (photo taken by others and provided to me by the client on the 27th January 2023), looking approximately east from the Britannia Hotel carpark. Also note the failure scar from the 2021 major branch failure.

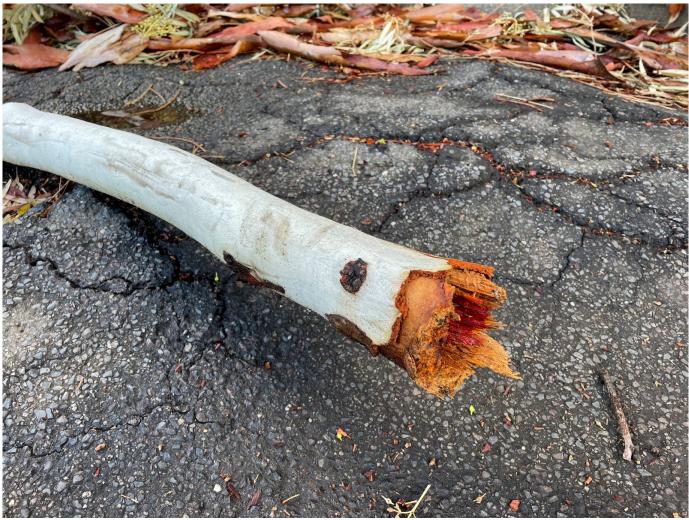
Figure 10. My photograph of the butt end of a minor branch (approximately 90 mm in diameter at its point of failure; photo taken on the 8th of March 2023) that failed from a height of approximately ten metres above ground level from the western canopy of the subject tree on the 18th February 2023 (about two weeks after the pruning of the tree that occurred on the 2nd of February 2023). This branch fell from the tree and hit the ground only a few seconds after a person drove a car out of the car park (as evidenced in video of the branch falling from the tree captured by CCTV footage at the site). This branch failure occurred in a healthy branch, at an internodal point, and in non-extreme weather, and is therefore indicative of a sudden branch failure event. The failed branch was likely over-extended and end-weighted (like most branches forming the canopy of the tree, despite the recent pruning) which likely contributed to the failure of this branch.

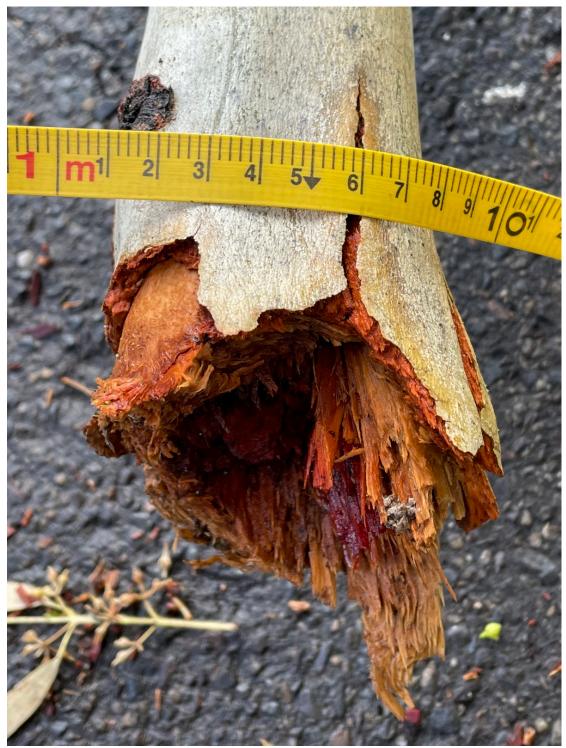
Figure 11. My close-up photograph of the butt end of a minor branch (approximately 90 mm in diameter at its point of failure; photo taken on the 8th of March 2023) that failed from a height of approximately ten metres above ground level from the western canopy of the subject tree on the 18th February 2023 (about two weeks after the pruning of the tree that occurred on the 2nd of February 2023). This branch fell from the tree and hit the ground only a few seconds after a person drove a car out of the car park (as evidenced in video of the branch falling from the tree captured by CCTV footage at the site). This branch failure occurred in a healthy branch, at an internodal point, and in non-extreme weather, and is therefore indicative of a sudden branch failure event.

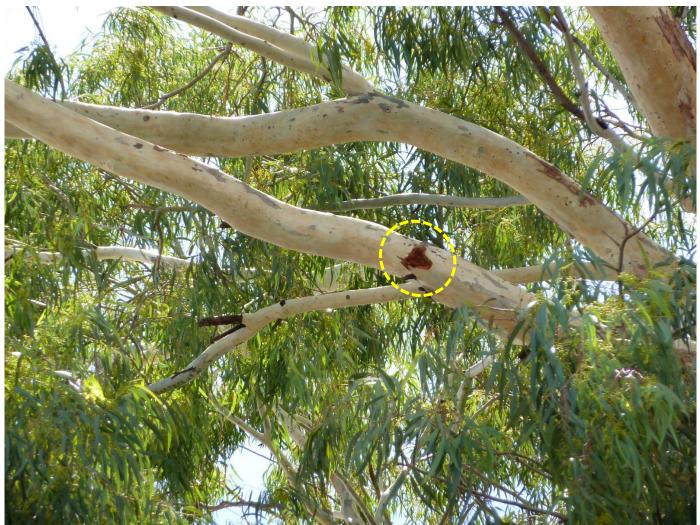
Figure 12. My photograph of the failure scar in the western canopy caused by the failure of a minor branch (approximately 90 mm in diameter at its point of failure; photo taken on the 8th of March 2023) that failed from a height of approximately ten metres above ground level from the western canopy of the subject tree on the 18th February 2023 (about two weeks after the pruning of the tree that occurred on the 2nd of February 2023; also see Figure 13). This branch fell from the tree and hit the ground only a few seconds after a person drove a car out of the car park (as evidenced in video of the branch falling from the tree captured by CCTV footage at the site). This branch failure occurred in a healthy branch, at an internodal point, and in non-extreme weather, and is therefore indicative of a sudden branch failure event. The failed branch was likely over-extended and end-weighted (like most branches forming the canopy of the tree, despite the recent pruning) which likely contributed to the failure of this branch.

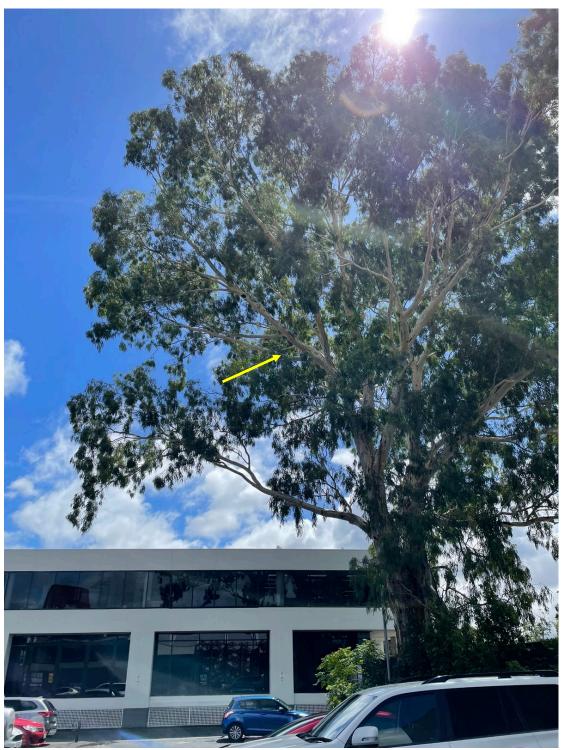
Figure 13. My photograph of the western and central canopy of the tree; looking approximately north from the Britannia Hotel carpark on the 8th of March 2023. The superimposed yellow arrow indicates the position of the failure scar caused by the failure of a minor branch (approximately 90 mm in diameter at its point of failure) that failed from a height of approximately ten metres above ground level from the western canopy of the subject tree on the 18th February 2023 (about two weeks after the pruning of the tree that occurred on the 2nd of February 2023; also see Figure 12). This branch fell from the tree and hit the ground only a few seconds after a person drove a car out of the car park (as evidenced in video of the branch falling from the tree captured by CCTV footage at the site).

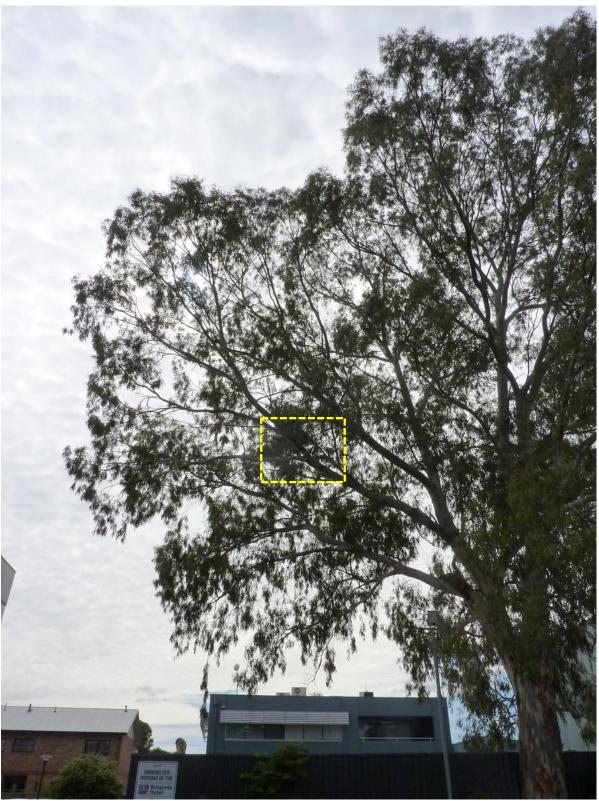
Figure 14 My photograph of the subject tree, looking approximately east from the Britannia Hotel carpark on the 9th of November 2021. The superimposed yellow rectangle indicates the field of view in Figure 7, where a primary branch in the northern canopy of the tree is structurally defective. The removal of this branch would open the canopy to other potential branch failures (noting other similar branches would also require removal). Also note the increasingly over-extended structure of most branches forming the canopy of the tree.

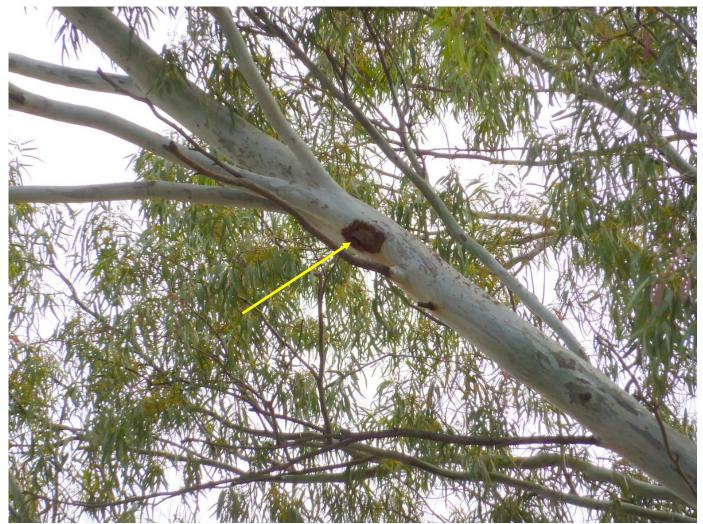
Figure 15. My photograph of a primary branch in the <u>western</u> canopy of the tree (refer to Figure 10) on the 9th of November 2021, with the superimposed yellow arrow indicating an entry/exit hole to longhorn borer pupal cells or galleries and surrounding damage to cambium by galahs/corellas/ cockatoos (presumably to access the insects for food). This branch is also structurally defective at this point, but its removal would open the canopy to other potential branch failures (noting other similar branches would also require removal).

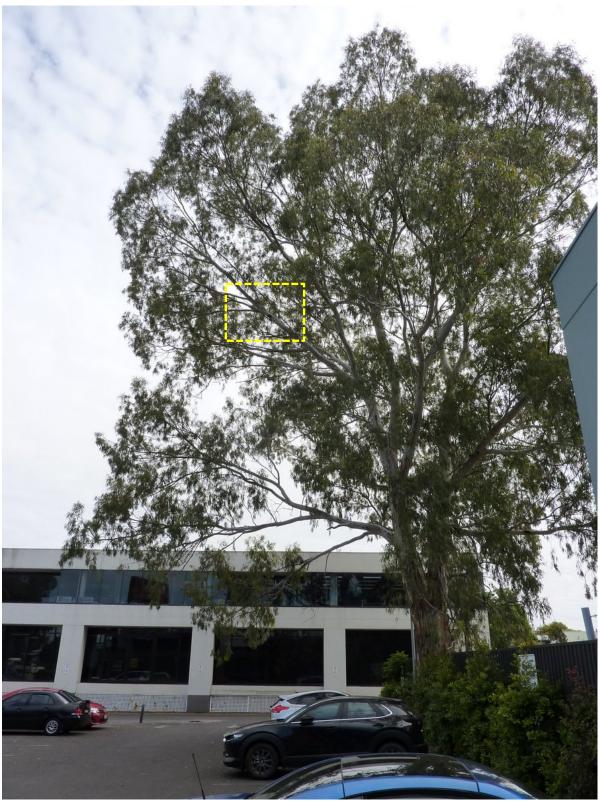
Figure 16. My photograph of the subject tree, looking approximately north from the Britannia Hotel carpark on the 9th of November 2021. The superimposed yellow rectangle indicates the field of view in Figure 9, where a primary branch in the northern canopy of the tree is structurally defective. The removal of this branch would open the canopy to other potential branch failures (noting other similar branches would also require removal). Also note the increasingly over-extended structure of most branches forming the canopy of the tree.

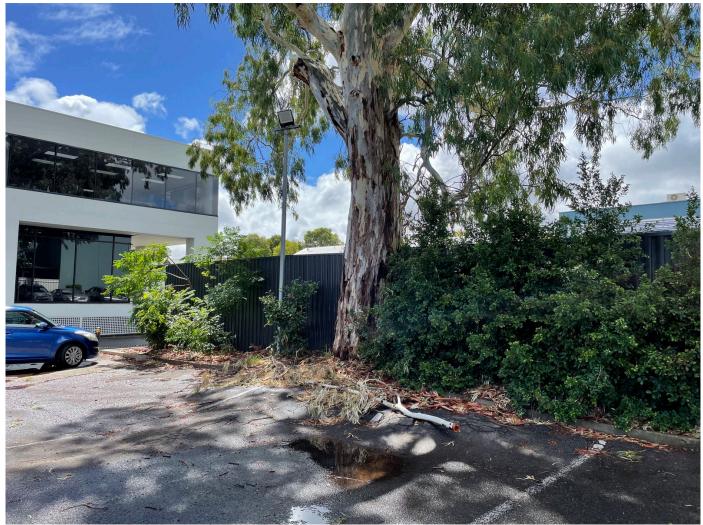
Figure 17. My photograph of the subject tree, looking approximately north-east from the Britannia Hotel carpark on the 8th of March 2023. There is up to 500 mm of vertical displacement of the bitumen-sealed surface of both the carpark at the Britannia Hotel carpark and the carpark in the allotment of 37-39 Wadham Lane, caused by an ongoing increase in the diameter of the roots of the tree. The concrete edge to the carpark at the Britannia Hotel has also been displaced by the tree.

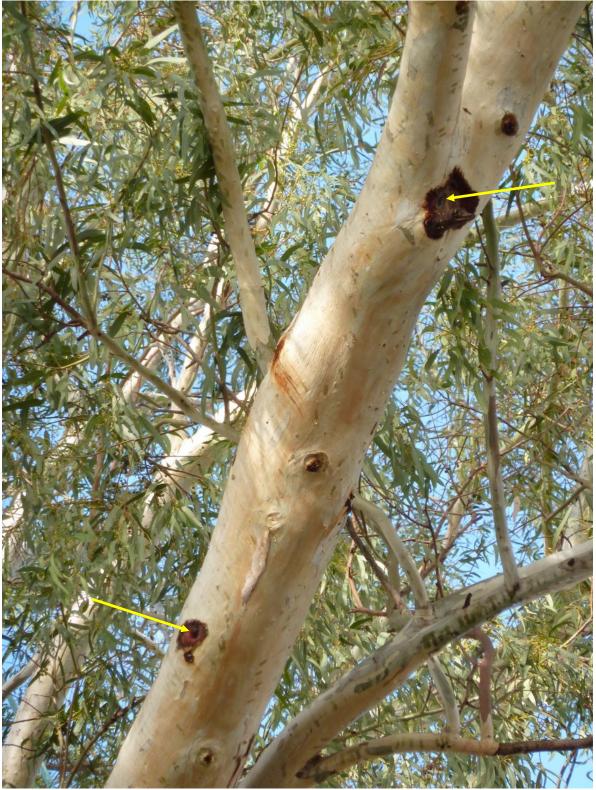
Figure 18. My photograph of a primary branch in the <u>northern</u> canopy of the tree (refer to Figure 19) on the 7th of June 2022, with the superimposed yellow arrows indicating entry/exit holes to longhorn borer pupal cells or galleries and surrounding damage to cambium by galahs/corellas/ cockatoos (presumably to access the insects for food). This branch is structurally defective at these points, but its removal would open the canopy to other potential branch failures (noting other similar branches would also require removal).

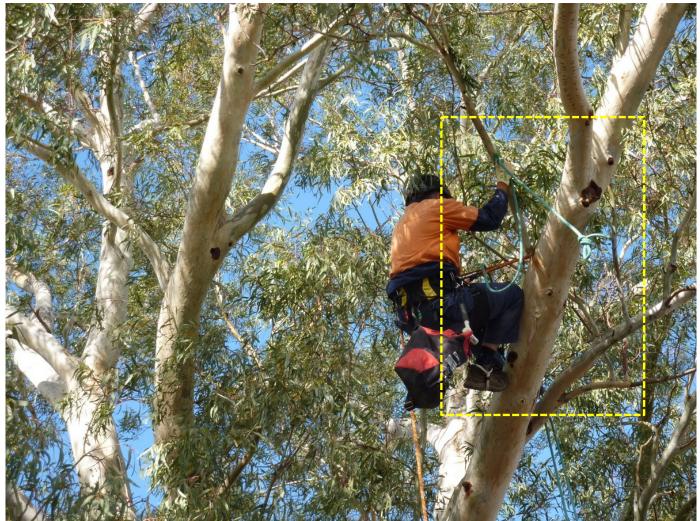
Figure 19. My photograph of part of the canopy of subject tree on the 7th of June 2022, looking approximately south from Wadham Lane. The superimposed yellow rectangle indicates the field of view in Figure 18, where a primary branch in the southern canopy of the tree is structurally defective. The removal of this branch would open the canopy to other potential branch failures.

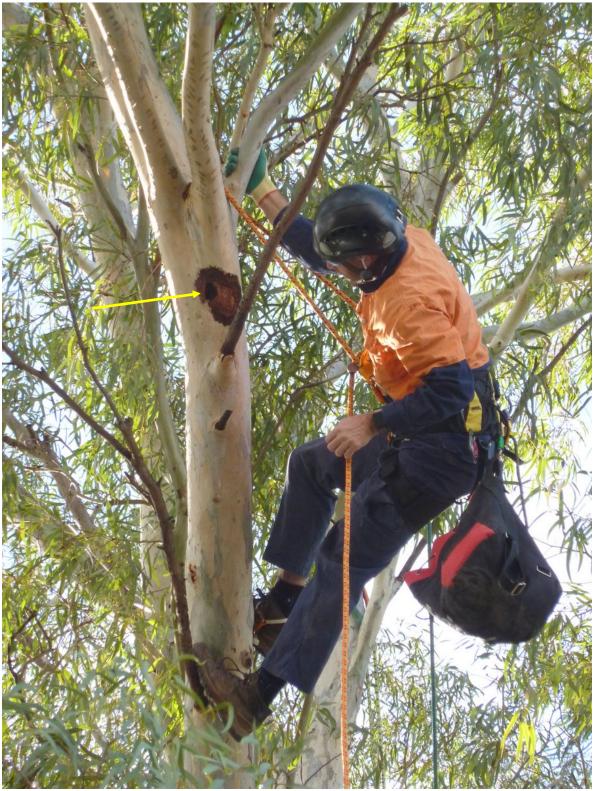
Figure 20. My photograph of a primary leader in the <u>upper, central</u> canopy of the tree (refer to Figure 21) on the 7th of June 2022, with the superimposed yellow arrow indicating an entry/exit hole to longhorn borer pupal cells or galleries and surrounding damage to cambium by galahs/corellas/ cockatoos (presumably to access the insects for food). This leader is structurally defective at this point, but its removal would significantly open the canopy to other potential branch failures (noting other similar branches would also require removal).

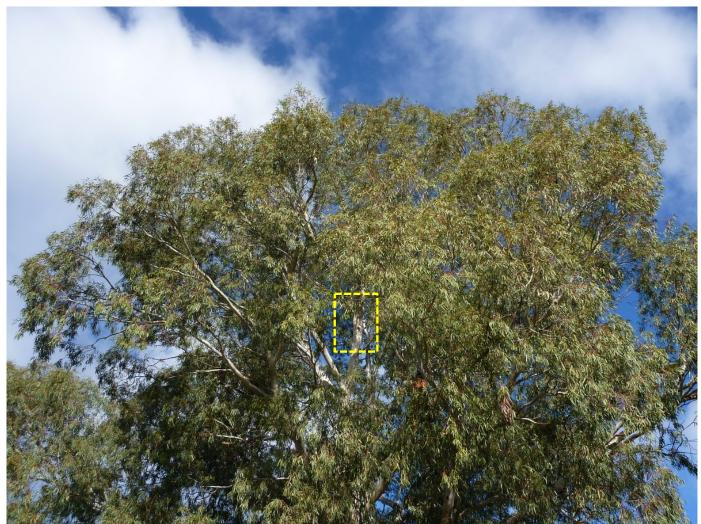
Figure 21. My photograph of the canopy of subject tree on the 7th of June 2022, looking approximately west from the carpark in the allotment of 37-39 Wadham Lane. The superimposed yellow rectangle indicates the field of view in Figure 20, where a primary leader is structurally defective. The removal of this leader would open the canopy to other potential branch failures.

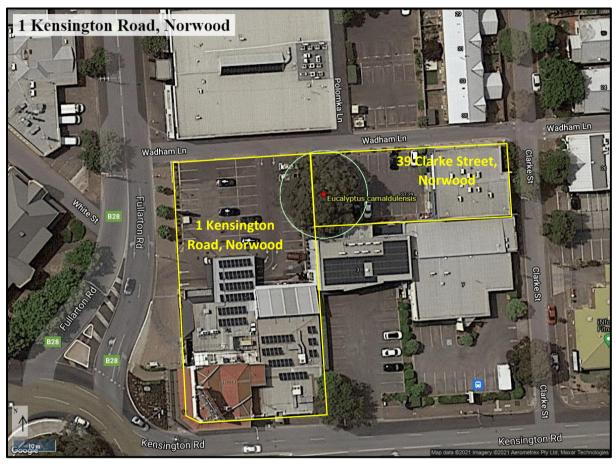
The tree's root zone consists of sealed surfacing in all directions surrounding the stem with a narrow linear garden bed extending to the north and south of the stem. A two-storey building housing office suites is situated approximately 13m to the south of the stem. There have been no obvious recent disturbances within this area. The surfacing of the bitumen car park into the east and west are both damaged within the structural root zone as a result of root development with various undulations and bitumen cracking.

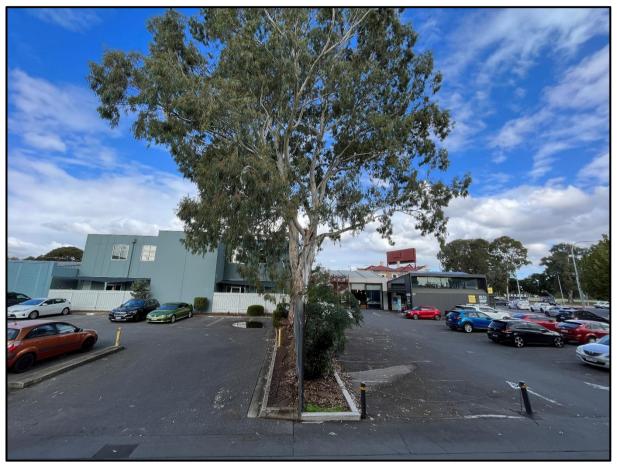
• Image above: The tree when viewed from the north. Branch arrangement and distribution is typical of the species and reduction pruning has been applied suitably. Small wounds are also visible on some branches within this image. These attributes are not expected to be causing health decline or tree stress at this time.

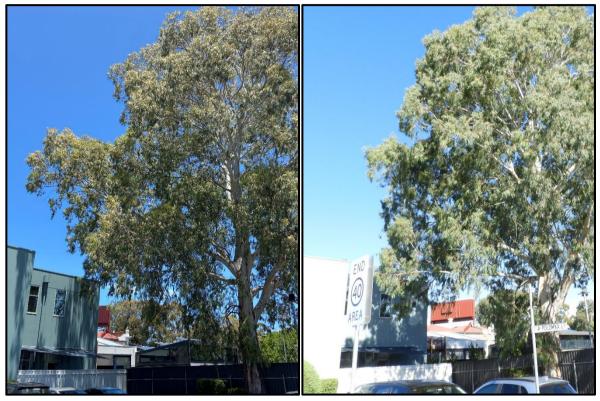
• Image above: The southeastern crown with substantially less extension as a result of the recent pruning (right image). The increase in foliage density is also notable in this image indicating good tree vigour and therefore ability to generate structural adaptations to maintain integrity following branch failure and pruning operations.

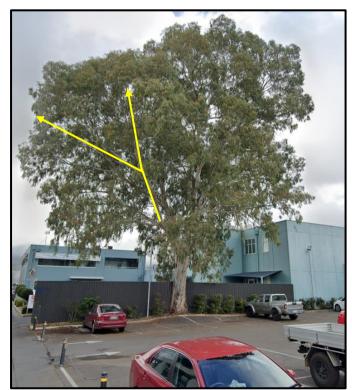
• Image right: The extension of the branch that failed prior to the failure event. (Google Maps Streetview dated August 2020).

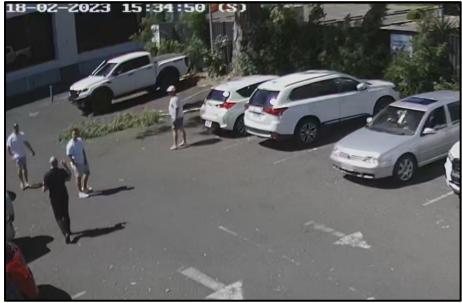
- Image right: An extract of the video provided by Duke Group 17 seconds post the branch failure decent. In this image, the branch is visible in the location where a vehicle had been parked however no damage to adjacent vehicle was reported.

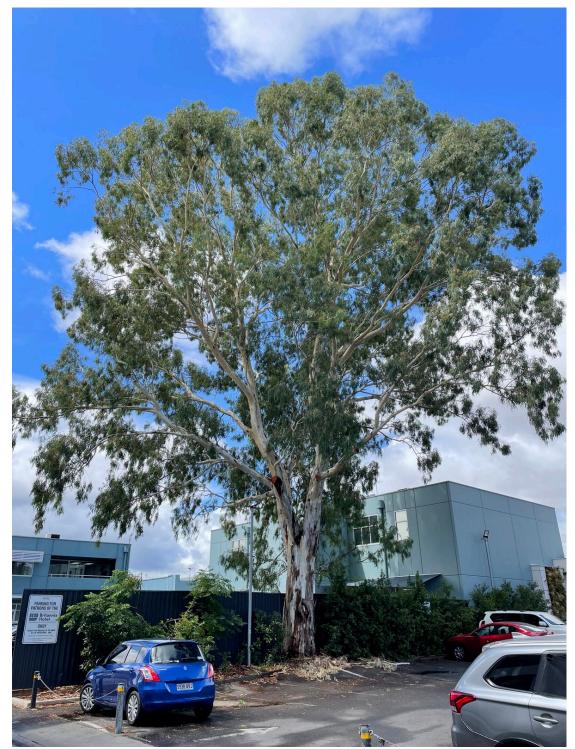
Figure 1. My photograph of the subject tree, looking approximately south-east from Wadham Lane on the 8th of March 2023, following the recent pruning of the tree (in February 2023) and the recent branch failure events from the tree (in January and February 2023). Note the large canopy of the tree overhanging a number of formal car parking spaces within the car park of the Britannia Hotel.

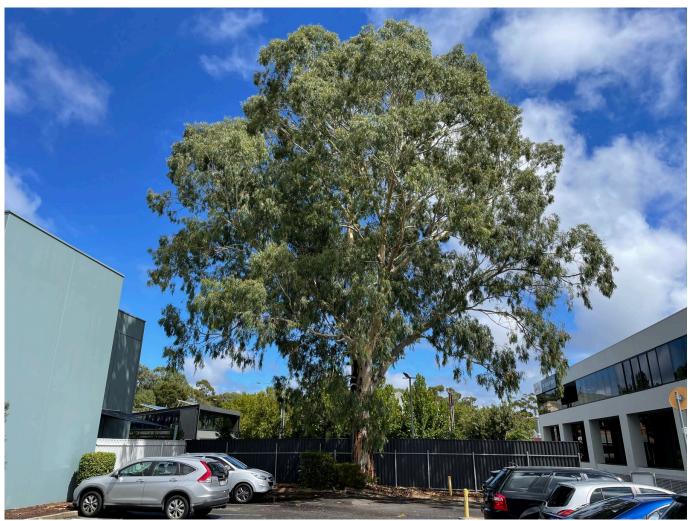
Figure 2. My photograph of the subject tree, looking approximately west from the carpark at 37-39 Wadham Lane on the 8^{th} of March 2023, following the recent pruning of the tree (in February 2023) and the recent branch failure events from the tree (in January and February 2023). Note the large canopy of the tree overhanging a number of formal car parking spaces within the car park at 37-39 Wadham Lane.

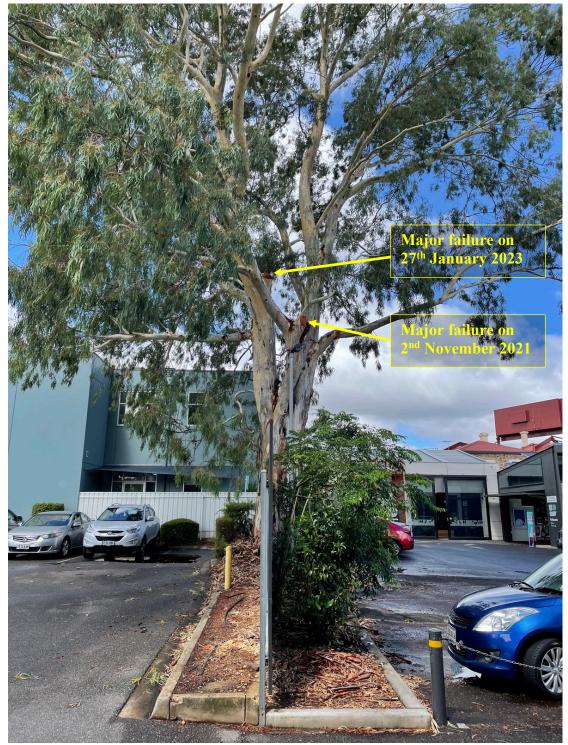
Figure 3. My photograph of the subject tree, looking south from Wadham Lane on the 8^{th} of March 2023. The pruning scars of the stubs from the two largest structural failures in the tree are indicated. Note that the canopy of the tree overhanging numerous car parking spaces at the Britannia Hotel carpark and in the neighboring allotment of 37-39 Wadham Lane.

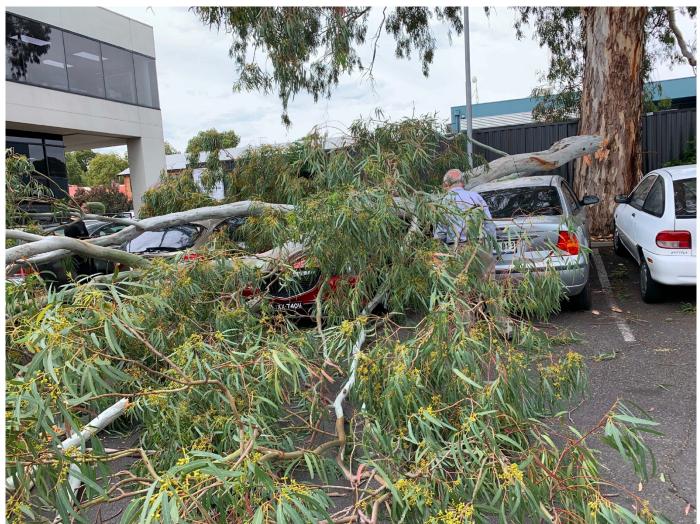
Figure 4. Photograph of the subject tree and the branch failure that occurred on the 2^{nd} November 2021 (photo taken by others and provided to me by Phillip Brunning of Phillip Brunning and Associates), looking approximately east from the Britannia Hotel carpark. Three vehicles were damaged by this branch failure event, which occurred in non-extreme weather.

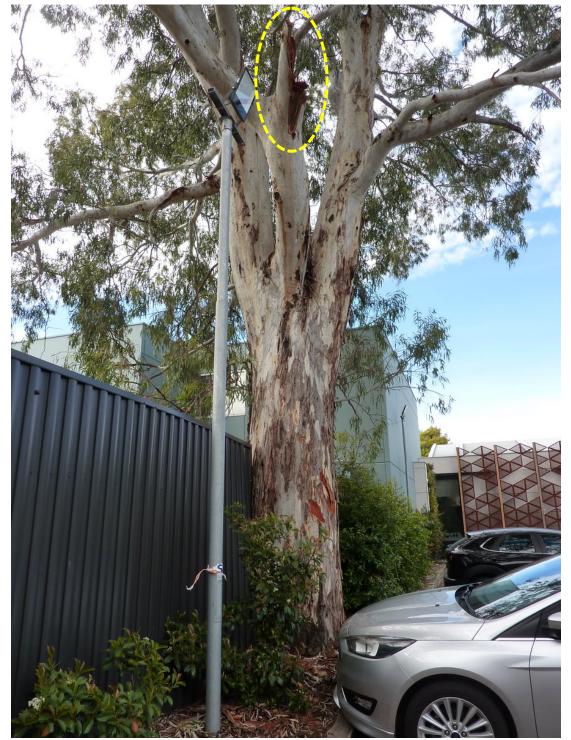
Figure 5. My photograph of the subject tree, looking approximately south from the Britannia Hotel carpark on the 9th of November 2021 (following a recent major branch failure). The superimposed yellow ring indicates the recent branch failure scar. This failure occurred in a healthy branch, at an internodal point, and in non-extreme weather, and is therefore indicative of a sudden branch failure event. The failed branch was likely over-extended and end-weighted (like most branches forming the canopy of the tree) and the failure scar indicates large longhorn borer galleries in the heartwood – both of these likely contributed to the failure of this branch (also see Figure 6). This failure scar has now been pruned back more cleanly, presumably for aesthetic reasons (see Figure 7).

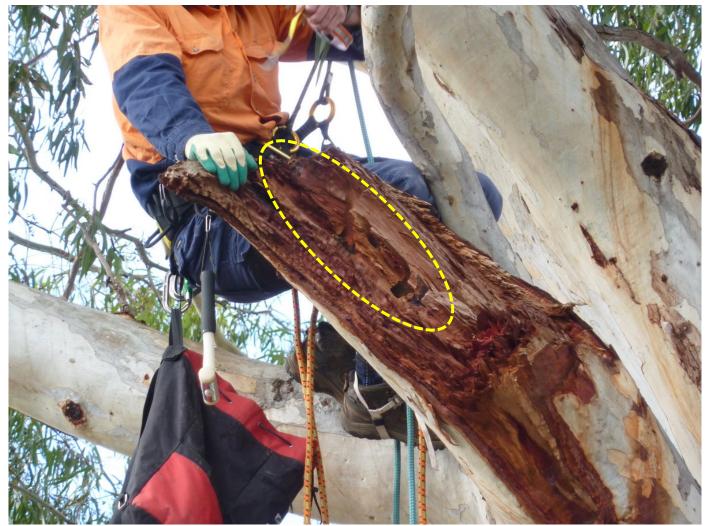
Figure 6. My photograph of the scar caused by the recent failure of a major branch from the tree, photographed on the 7th of June 2022. This failure occurred in a healthy branch, at an internodal point, and in non-extreme weather, and is therefore indicative of a sudden branch failure event. The failed branch was likely overextended and end-weighted (like most branches forming the canopy of the tree) and the failure scar indicates large longhorn borer galleries in the heartwood – both of these likely contributed to the failure of this branch. The superimposed yellow ring indicates the area where longhorn borers have created large heartwood galleries and pupal chambers. This failure scar has now been pruned back more cleanly, presumably for aesthetic reasons (see Figure 7).

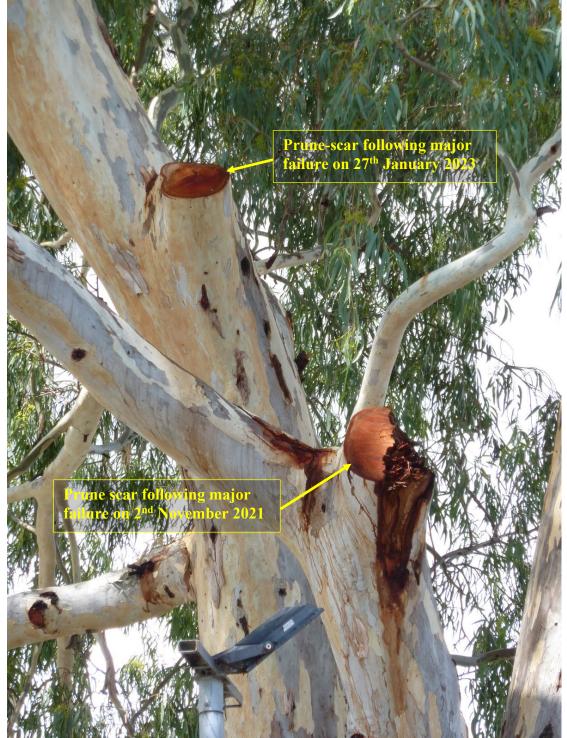
Figure 7. My photograph of the subject tree, looking approximately south-east from the Britannia Hotel carpark on the δ^{th} of March 2023. The pruning scars of the stubs from the two largest structural failures in the tree are indicated. Both of these failure scars have been pruned back more cleanly, presumably for aesthetic reasons.

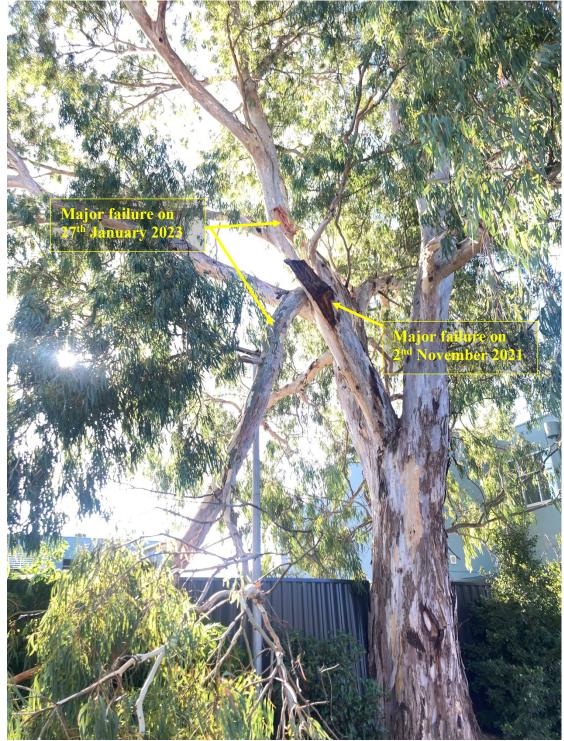
Figure 8. Photograph of the subject tree and the branch failure that occurred on the 27th January 2023 (photo taken by others and provided to me by the client on the 27th January 2023), looking approximately east from the Britannia Hotel carpark. Also note the failure scar from the 2021 major branch failure.

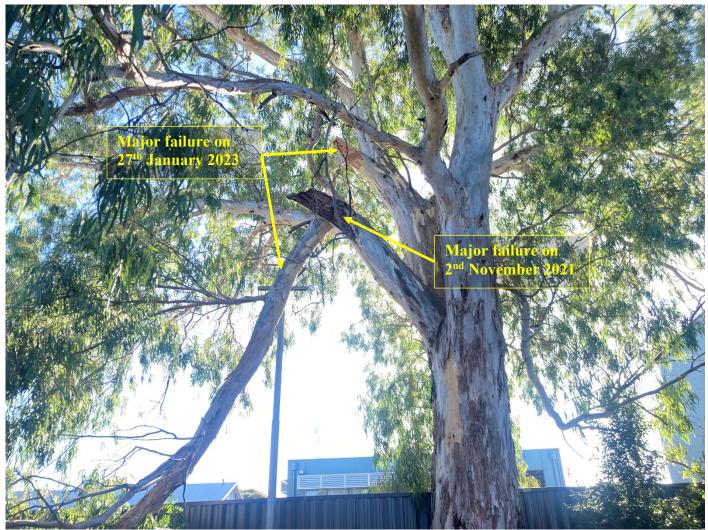
Figure 9. Photograph of the subject tree and the branch failure that occurred on the 27th January 2023 (photo taken by others and provided to me by the client on the 27th January 2023), looking approximately east from the Britannia Hotel carpark. Also note the failure scar from the 2021 major branch failure.

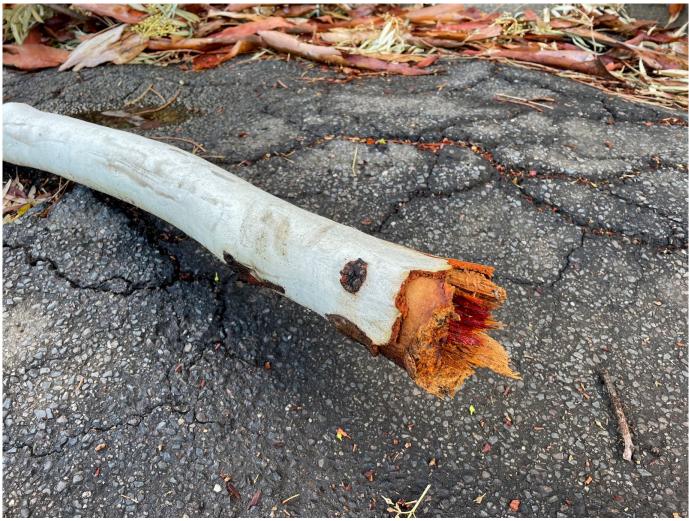
Figure 10. My photograph of the butt end of a minor branch (approximately 90 mm in diameter at its point of failure; photo taken on the 8th of March 2023) that failed from a height of approximately ten metres above ground level from the western canopy of the subject tree on the 18th February 2023 (about two weeks after the pruning of the tree that occurred on the 2nd of February 2023). This branch fell from the tree and hit the ground only a few seconds after a person drove a car out of the car park (as evidenced in video of the branch falling from the tree captured by CCTV footage at the site). This branch failure occurred in a healthy branch, at an internodal point, and in non-extreme weather, and is therefore indicative of a sudden branch failure event. The failed branch was likely over-extended and end-weighted (like most branches forming the canopy of the tree, despite the recent pruning) which likely contributed to the failure of this branch.

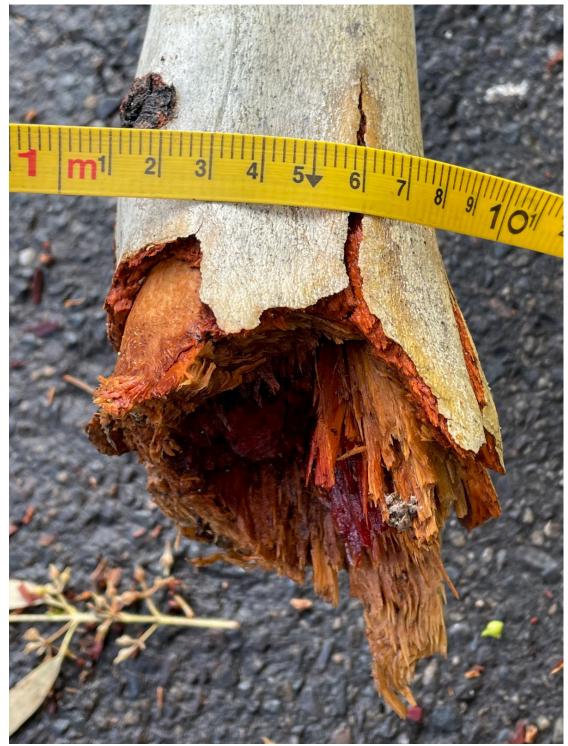
Figure 11. My close-up photograph of the butt end of a minor branch (approximately 90 mm in diameter at its point of failure; photo taken on the 8th of March 2023) that failed from a height of approximately ten metres above ground level from the western canopy of the subject tree on the 18th February 2023 (about two weeks after the pruning of the tree that occurred on the 2nd of February 2023). This branch fell from the tree and hit the ground only a few seconds after a person drove a car out of the car park (as evidenced in video of the branch falling from the tree captured by CCTV footage at the site). This branch failure occurred in a healthy branch, at an internodal point, and in non-extreme weather, and is therefore indicative of a sudden branch failure event.

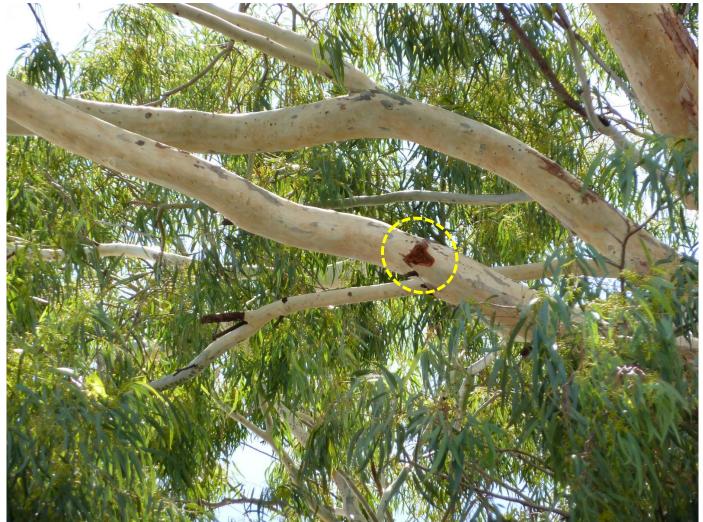
Figure 12. My photograph of the failure scar in the western canopy caused by the failure of a minor branch (approximately 90 mm in diameter at its point of failure; photo taken on the 8th of March 2023) that failed from a height of approximately ten metres above ground level from the western canopy of the subject tree on the 18th February 2023 (about two weeks after the pruning of the tree that occurred on the 2nd of February 2023; also see Figure 13). This branch fell from the tree and hit the ground only a few seconds after a person drove a car out of the car park (as evidenced in video of the branch falling from the tree captured by CCTV footage at the site). This branch failure occurred in a healthy branch, at an internodal point, and in non-extreme weather, and is therefore indicative of a sudden branch failure event. The failed branch was likely over-extended and end-weighted (like most branches forming the canopy of the tree, despite the recent pruning) which likely contributed to the failure of this branch.

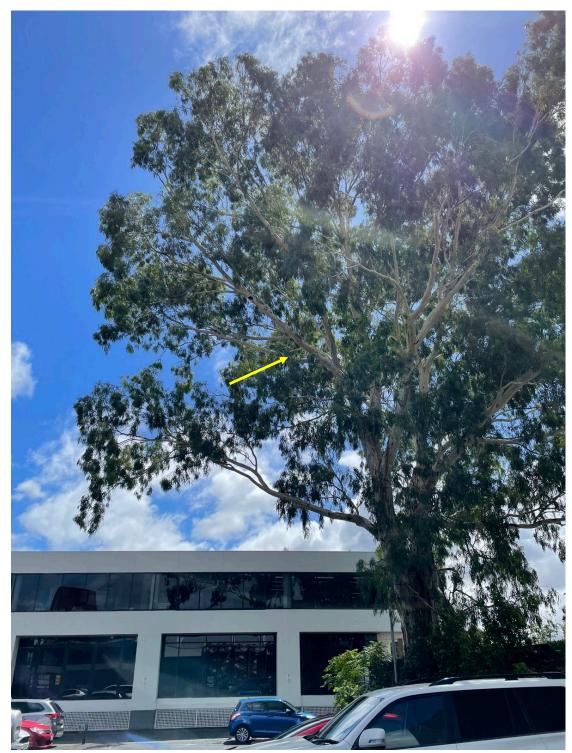
Figure 13. My photograph of the western and central canopy of the tree; looking approximately north from the Britannia Hotel carpark on the 8th of March 2023. The superimposed yellow arrow indicates the position of the failure scar caused by the failure of a minor branch (approximately 90 mm in diameter at its point of failure) that failed from a height of approximately ten metres above ground level from the western canopy of the subject tree on the 18th February 2023 (about two weeks after the pruning of the tree that occurred on the 2nd of February 2023; also see Figure 12). This branch fell from the tree and hit the ground only a few seconds after a person drove a car out of the car park (as evidenced in video of the branch falling from the tree captured by CCTV footage at the site).

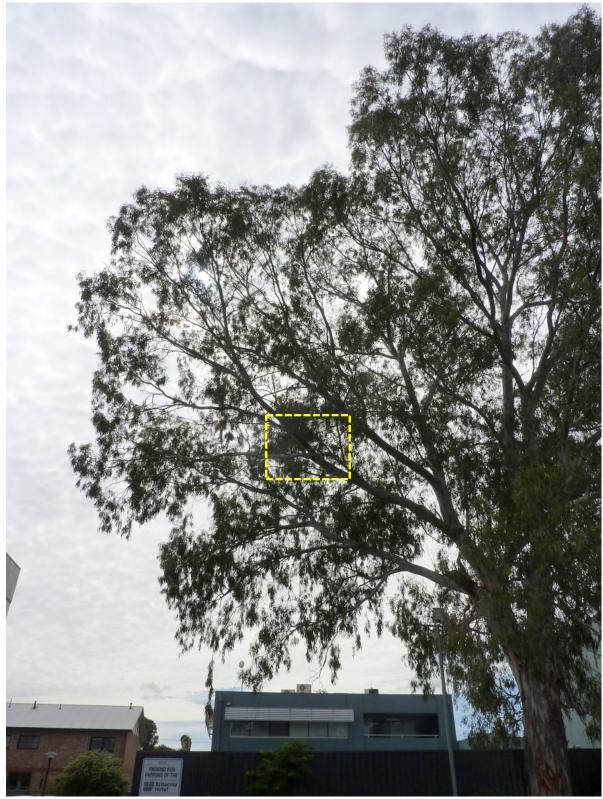
Figure 14 My photograph of the subject tree, looking approximately east from the Britannia Hotel carpark on the 9th of November 2021. The superimposed yellow rectangle indicates the field of view in Figure 7, where a primary branch in the northern canopy of the tree is structurally defective. The removal of this branch would open the canopy to other potential branch failures (noting other similar branches would also require removal). Also note the increasingly over-extended structure of most branches forming the canopy of the tree.

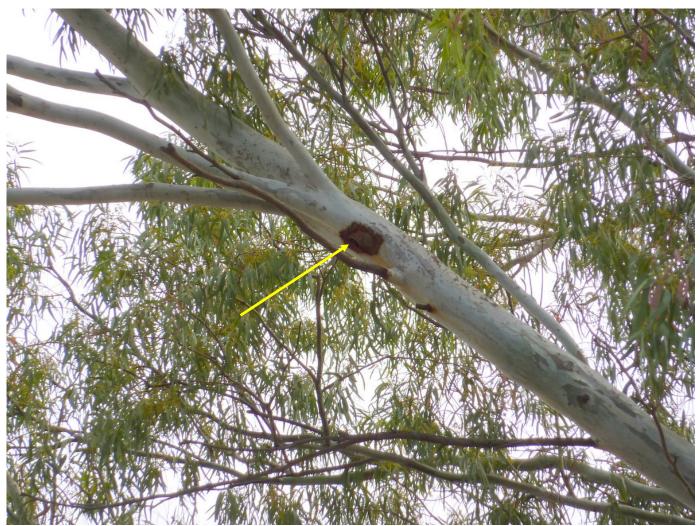
Figure 15. My photograph of a primary branch in the <u>western</u> canopy of the tree (refer to Figure 10) on the 9th of November 2021, with the superimposed yellow arrow indicating an entry/exit hole to longhorn borer pupal cells or galleries and surrounding damage to cambium by galahs/corellas/ cockatoos (presumably to access the insects for food). This branch is also structurally defective at this point, but its removal would open the canopy to other potential branch failures (noting other similar branches would also require removal).

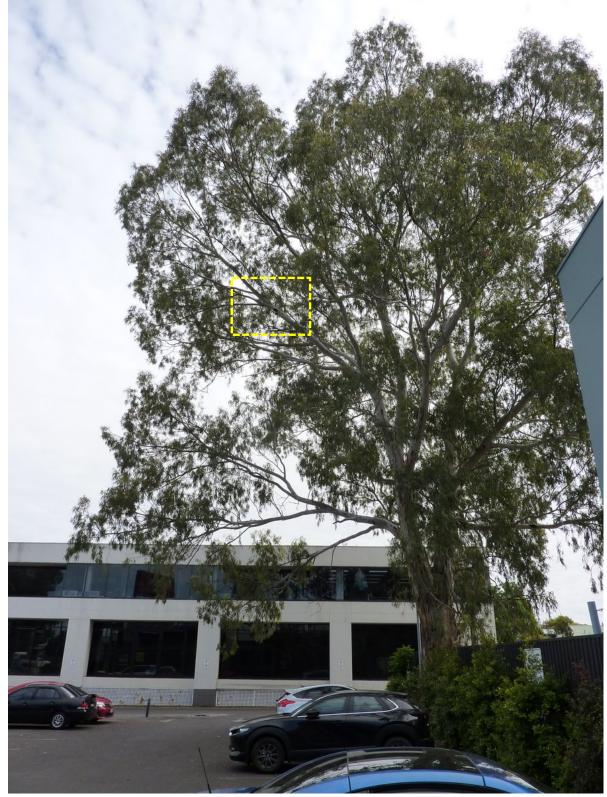
Figure 16. My photograph of the subject tree, looking approximately north from the Britannia Hotel carpark on the 9th of November 2021. The superimposed yellow rectangle indicates the field of view in Figure 9, where a primary branch in the northern canopy of the tree is structurally defective. The removal of this branch would open the canopy to other potential branch failures (noting other similar branches would also require removal). Also note the increasingly over-extended structure of most branches forming the canopy of the tree.
