Special Council Assessment Panel Agenda & Reports

15 August 2023

TREE TO BE REMOVED 1 Kensington Road & 39 Clarke Street, Norwood

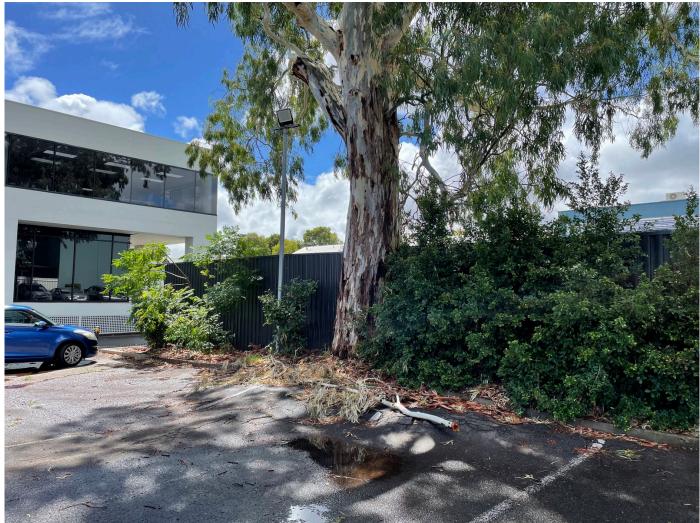
Figure 17. My photograph of the subject tree, looking approximately north-east from the Britannia Hotel carpark on the 8th of March 2023. There is up to 500 mm of vertical displacement of the bitumen-sealed surface of both the carpark at the Britannia Hotel carpark and the carpark in the allotment of 37-39 Wadham Lane, caused by an ongoing increase in the diameter of the roots of the tree. The concrete edge to the carpark at the Britannia Hotel has also been displaced by the tree.

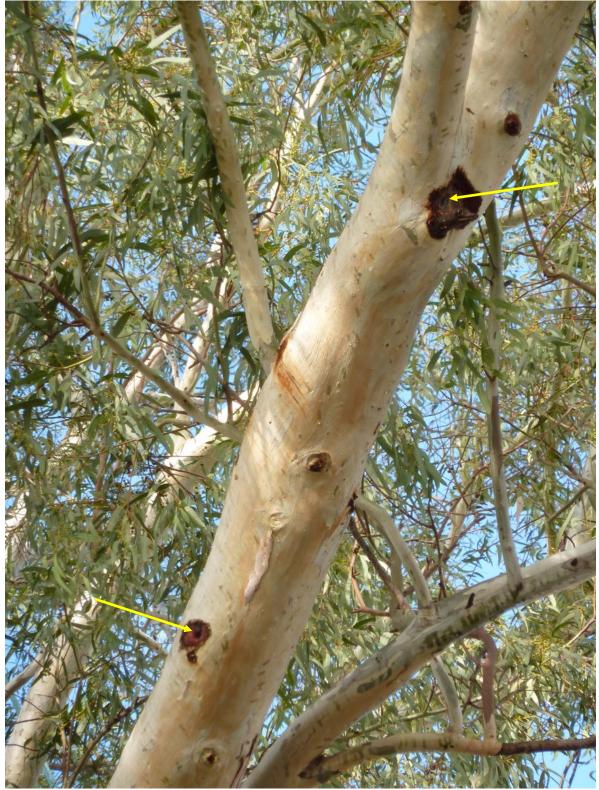
Figure 18. My photograph of a primary branch in the <u>northern</u> canopy of the tree (refer to Figure 19) on the 7th of June 2022, with the superimposed yellow arrows indicating entry/exit holes to longhorn borer pupal cells or galleries and surrounding damage to cambium by galahs/corellas/ cockatoos (presumably to access the insects for food). This branch is structurally defective at these points, but its removal would open the canopy to other potential branch failures (noting other similar branches would also require removal).

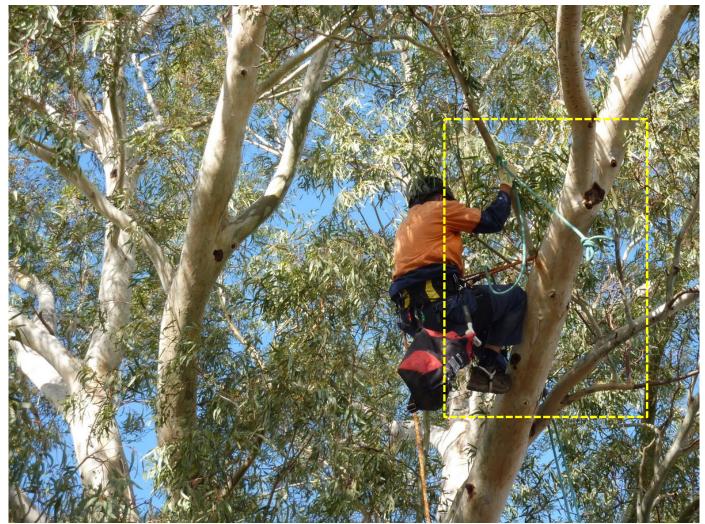
Figure 19. My photograph of part of the canopy of subject tree on the 7th of June 2022, looking approximately south from Wadham Lane. The superimposed yellow rectangle indicates the field of view in Figure 18, where a primary branch in the southern canopy of the tree is structurally defective. The removal of this branch would open the canopy to other potential branch failures.
