Special Council Assessment Panel Agenda & Reports

15 August 2023

TREE TO BE REMOVED 1 Kensington Road & 39 Clarke Street, Norwood

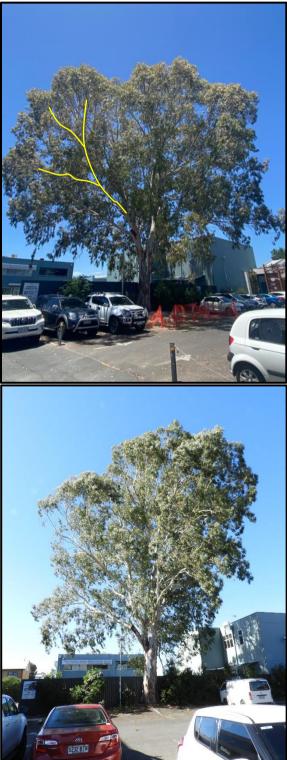
Image right: The subject tree when looking from the northwest on the 14th December 2021. The yellow perforated line illustrates the location and extent of the large diameter branch failure that occurred during late January 2023.

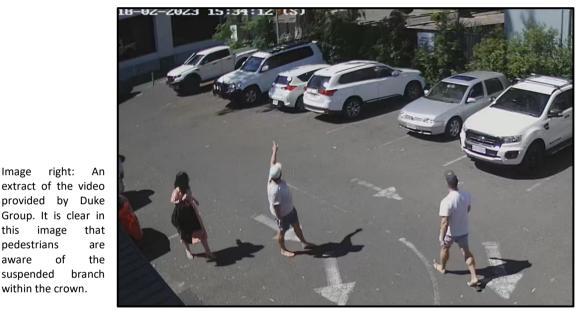
On the 18th February 2023 it was observed that a small diameter branch failure occurred within the middle western crown and above a car parking area. A video was provided of the incident enabling a clear timeline of the event. Assessment of the information available indicates that:

- A small diameter branch failed from within the middle western crown and fell unimpeded to the ground from an unknown height.
- It is likely that the branch became entangled within the lower branch on its descent, giving doubt to prescribing an accurate fall distance. This is evident by the people within the video realising the branch had failed and had time to react to the incident.

- The branch had partially failed prior to the presence of people within the failure target area.
- Three cars were present in the vicinity of the location where the failed branch landed.
- A vehicle owner moved to the failure target zone after the branch failure had occurred to move a vehicle.
- The branch fell from its place of lodgement immediately following the departure of this vehicle.

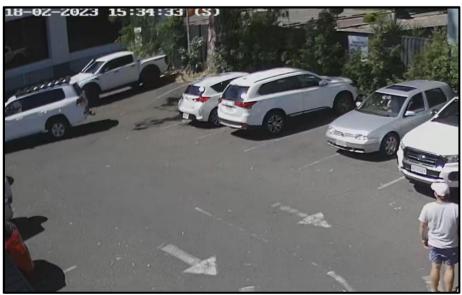
Image right: An extract of the video provided by Duke Group 31 seconds post the initial video extract above. In this image, the branch is visible falling in the location where the vehicle had been moved from.
